Reflective Cracking Construction Notes

Date: January 14, 2015

Project: Reflective Cracking Indoor Phase IV

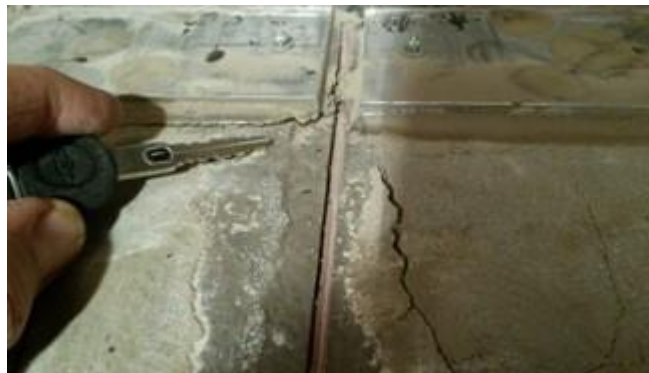
An unexplained error in the reflective cracking test rig motion controls occurred in the late morning. This error caused the South side of the test rig to close from 250 to 0 mils. This movement caused damage to the concrete surface of the rig and visible crack initiation in the base of the asphalt overlay on the inner and outer edges of the South test item and the inner edge of the North test item, as detailed in figures 1a – 1e.

(a) South inner section: concrete surface crack occurred when joint fully closed and both sections collided with each other. Left mounting bracket partly detached from surface.

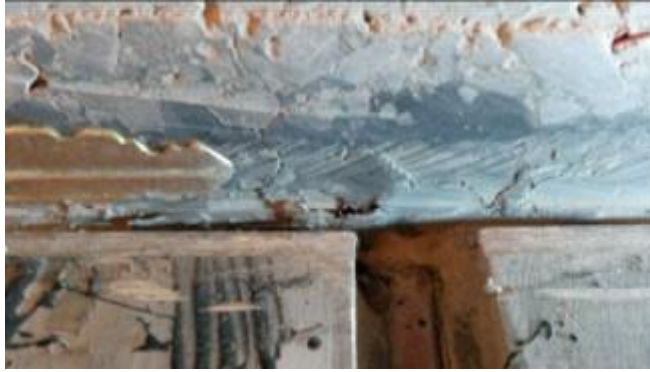
(b) South inner vertical edge: vertical and horizontal cracks at the joint area.

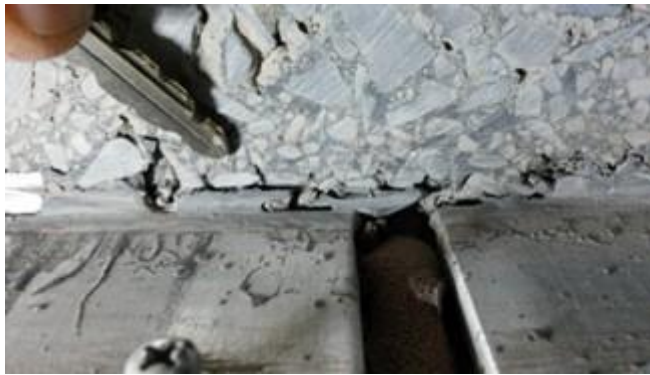
(c) South outer vertical edge: separation from the concrete surface.

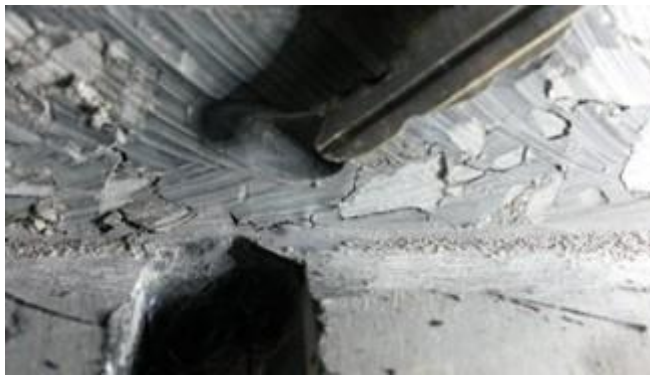
(d) North inner vertical edge: cracks at the joint area.

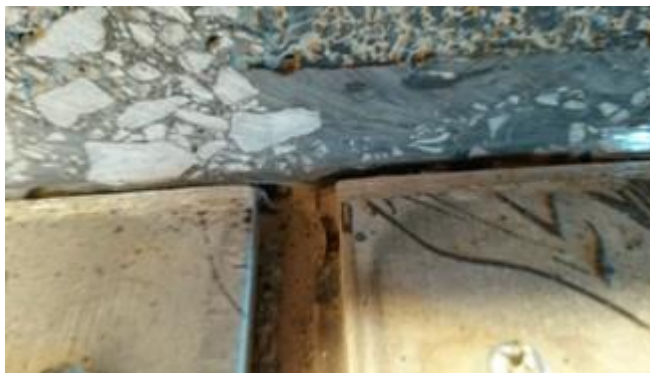
(e) North outer vertical edge: no evidence of cracks.
